Manhole Inspection Summary

Manhole # S37CC_022MH

Insp Date: **8/25/09 9:38 PM**

Location Address: **926 Greenmount Ave.**

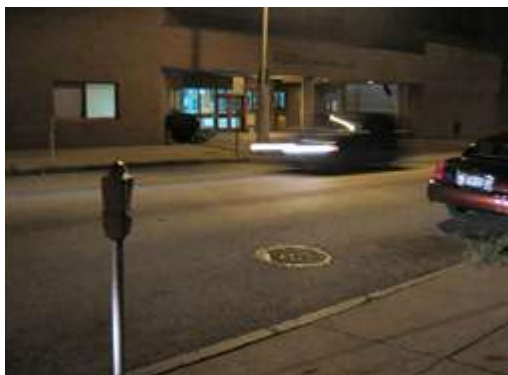
Location View

View facing southeast

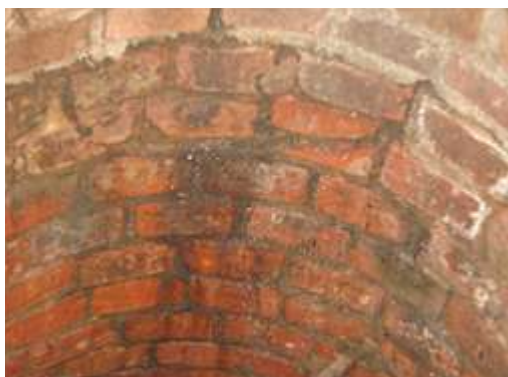
Defect 3

Infiltration: ☐ None ☐ Joint ☐ Cracks ☒ Mortar ☐ Roots ☒ Wall

corbel infiltration from mortar/wall

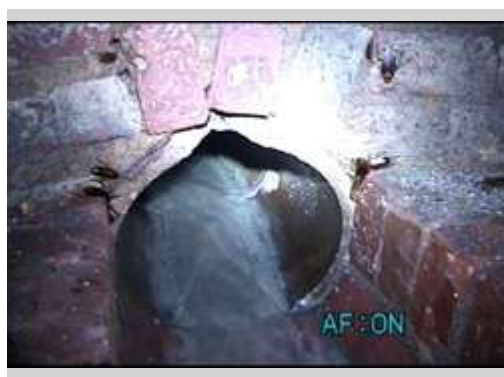
Defect 2

broken seal at 12 o clock pipe

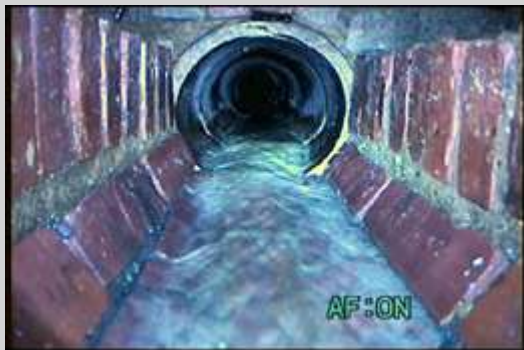
12 O'Clock Outflow

Pipe Height: **8.4** (in.) Rod and Bar (Angled)
Pipe Material: **Clay** ☐ Pipe Lined
Invert Depth: **9.91** (ft.) Flow Characteristics: **Slow**
Deposits: ☒ None ☐ Mud ☐ Sludge ☐ Debris ☐ Grease
Silt Depth: **0** (in.) Deposits Extent:
Infiltration: **None** Pipe Seal Cond: **Broken**

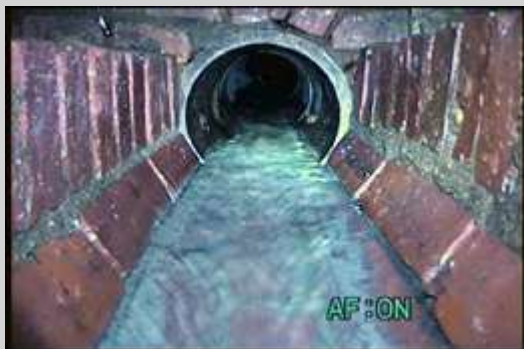
6 O'Clock Inflow

Pipe Height: **8.4** (in.) Rod and Bar (Angled)
Pipe Material: **Clay** ☐ Pipe Lined
Invert Depth: **9.90** (ft.) Flow Characteristics: **Slow**
Deposits: ☒ None ☐ Mud ☐ Sludge ☐ Debris ☐ Grease
Silt Depth: **0** (in.) Deposits Extent:
Infiltration: **None** Pipe Seal Cond: **Sound**
